ORCAS ISLAND AIRPORT

Final Environmental Assessment

Obstruction Removal

October 2016

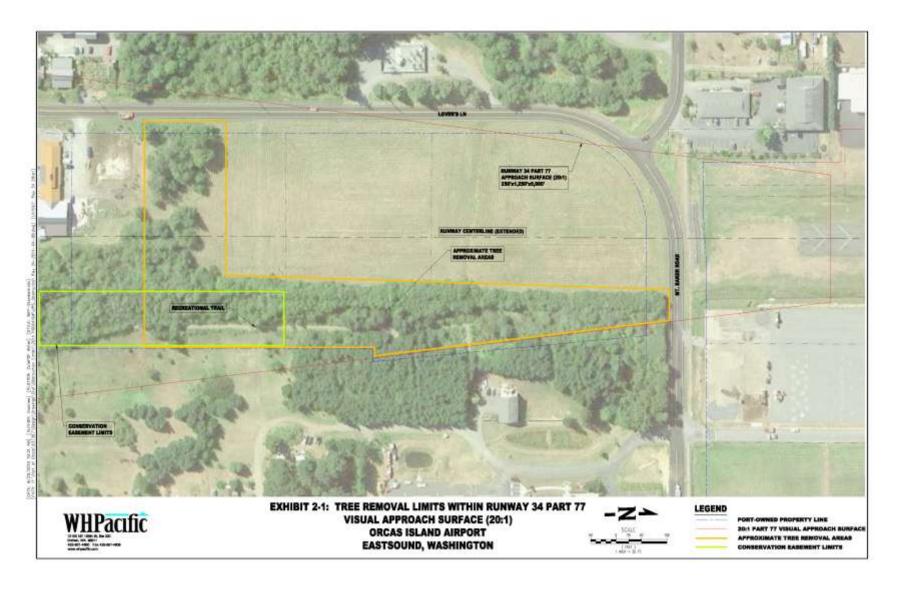
Exhibit 2-1 Tree Removal Limits Within Runway 34 Part 77 Visual Approach Surface 20:1

The proposed action is necessary because the current approach surfaces for Runway 34 does not meet the FAA regulations, which are meant to enhance safety. The proposed clearing of existing and future vegetation obstructions is needed to maintain the 20:1 visual approach surface for Runway 34.

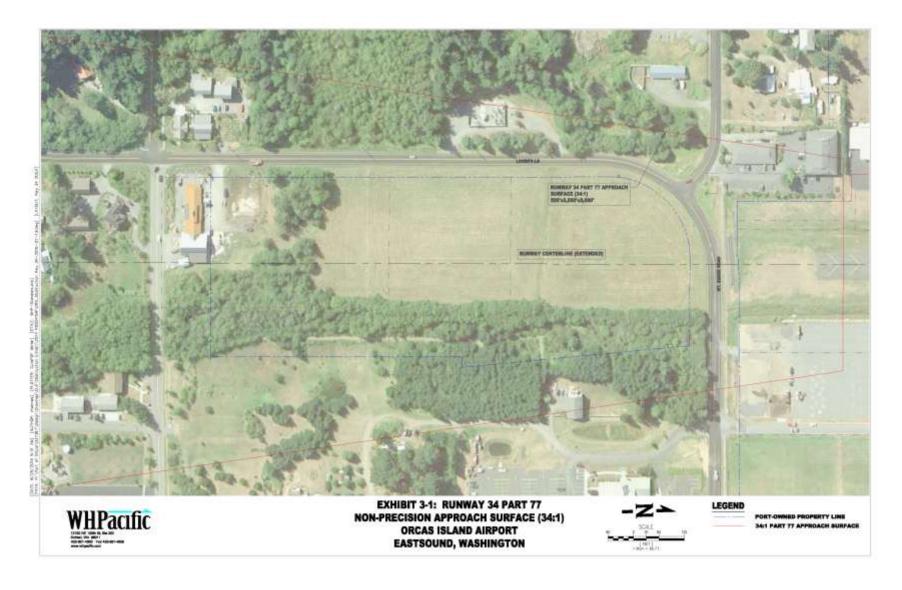
Exhibit 3-1 Runway 34 Part 77 Non-Precision Approach Surface (34:1)

Alternative 3 includes complete vegetation removal, consisting of all trees, shrubs, and stumps within the Runway 34 non-precision approach surface as shown in **Exhibit 3-1**. The 34:1 non-precision approach surface is a trapezoidal shape that is 5,000 feet long with inner and outer widths of 500 feet and 2,000 feet, respectively. The Port owns the land in the center portion of the non-precision approach surface. There are multiple private owners within the remainder of the approach surface areas. This alternative would meet the Purpose and Need as it removes the existing and potential obstructions in the approach surface; however, a portion of the vegetation removal area is located outside of the Port-owned property and would require landowner permission or potential purchase of the easements.

Because the non-precision approach surface covers areas outside of the Port-owned property, Alternative 3 will not be considered for further analysis. The Port is scheduled to conduct an Airport Master Plan Update next year, when a full obstruction analysis will be conducted for all the FAR Part-77 surfaces as part of the Master Plan Update.

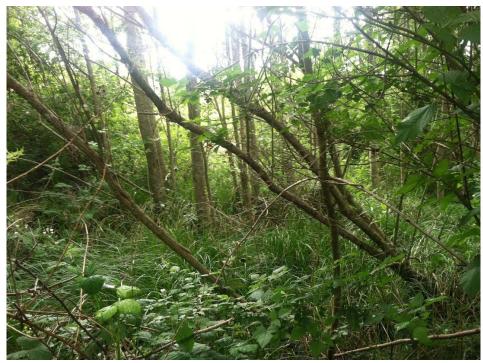
Photo 2: Emergent wetland within forested area. Willow spp., English hawthorn, Himalayan blackberry, slough sedge.

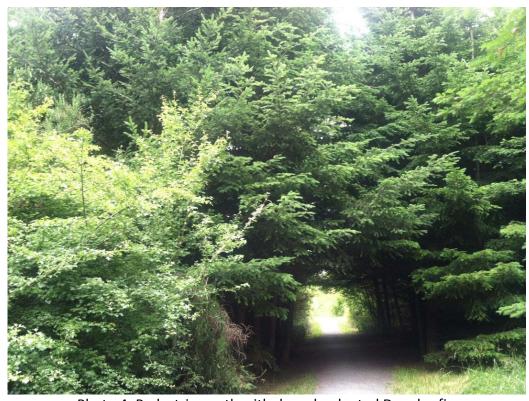
Photo 4: Pedestrian path with densely-planted Douglas fir.

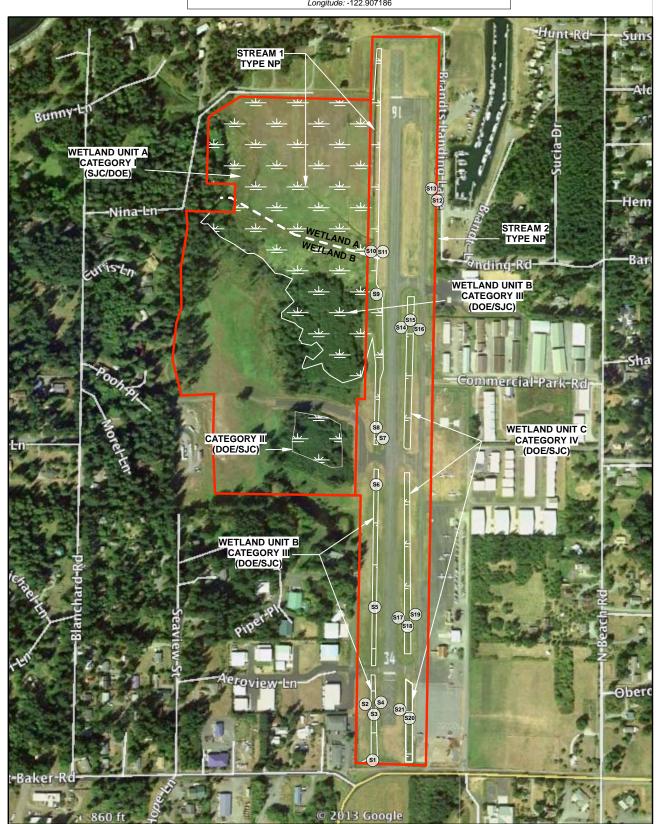
FIGURE 1: DATA SITE LOCATION MAP - AIRPORT SITE ORCAS ISLAND AIRPORT Section 11, Township 37N, Range 2W, W.M. Latitude: 48.706192 Longitude: -122.907186

LEGEND (\$1)—(\$21) FIELD DATA SITES 1-21 PURPOSE:

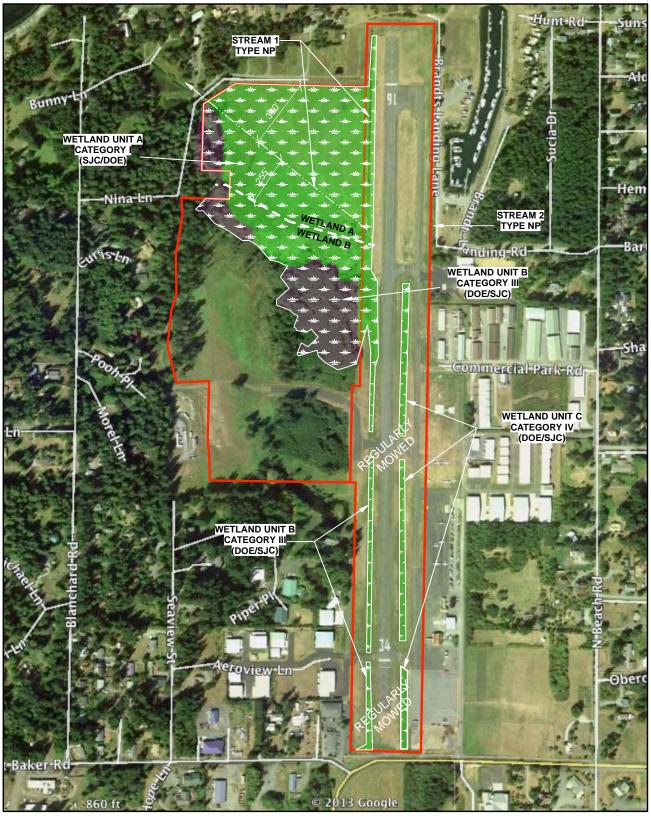
FIGURE A1: Cowardin Plant Classes & Plant Cover - Airport Site
ORCAS ISLAND AIRPORT
Section 11, Township 37N, Range 2W, W.M.
Latitude: 48.706192
Longitude: -122.907186

= FORESTED

= EMERGENT

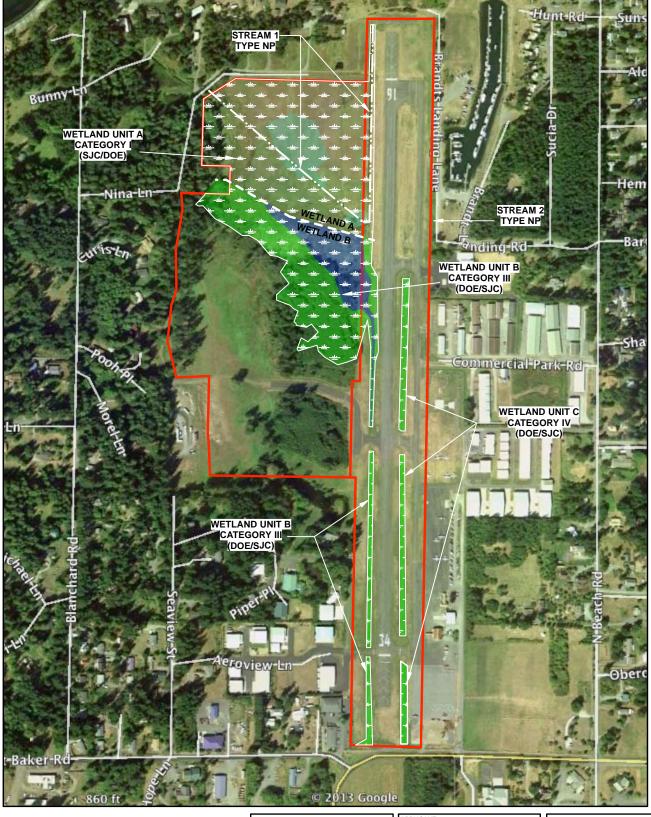
COUNTY: San Juan STATE: Washington Figure A2 DATE: May 2015 FIGURE B1: Hydroperiods & Ponded Depressions - Airport Site
ORCAS ISLAND AIRPORT
Section 11, Township 37N, Range 2W, W.M.
- Latitude: 48.706192
Longitude: -122.907186

= Saturated only

= Seasonally ponded

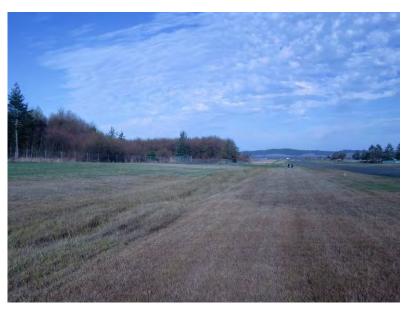
Overview of cut area - indicated by a gradual east-facing slope - along the west-central margin of the Orcas Airport runway. View north-northwest.

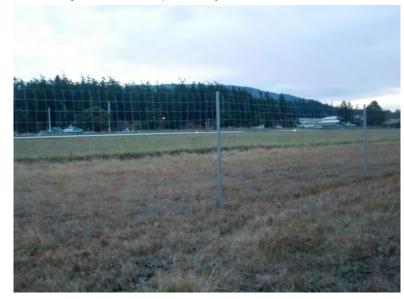
Overview of fill area at southern third of the Orcas Airport runway. Note increase in elevation associated with airstrip in background. View east.
