YEAR TWO MONITORING REPORT

ORCAS ISLAND AIRPORT
SAN JUAN COUNTY, WA

Wetland Resources, Inc. Project #19055

December 9, 2021

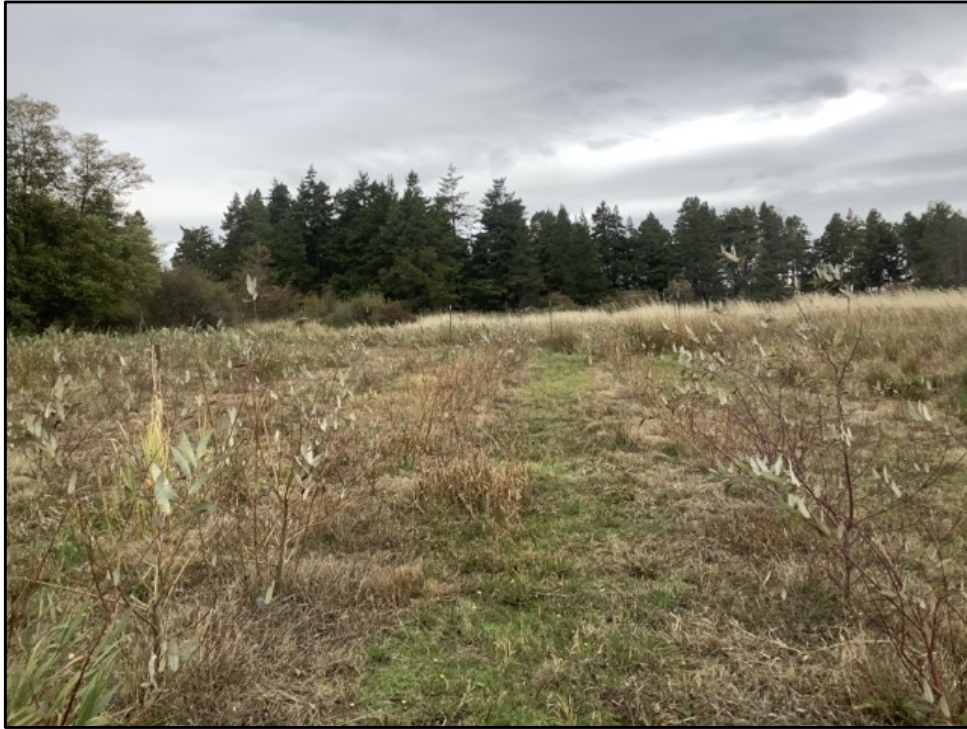
WETLAND ENHANCEMENT AREA 1, ZONE 1A, PLOT 1-1 (35'X55')		
Species	Year 1 Quantity in Sampling Plot	Year 2 Quantity in Sampling Plot
<i>Salix spp.</i>	70	70
Total:	70	70
Percent Survival:		100%

PHOTO 1: PLOT 1-1. LOOKING NORTH IN WETLAND
ENHANCEMENT AREA 1, ZONE 1A.

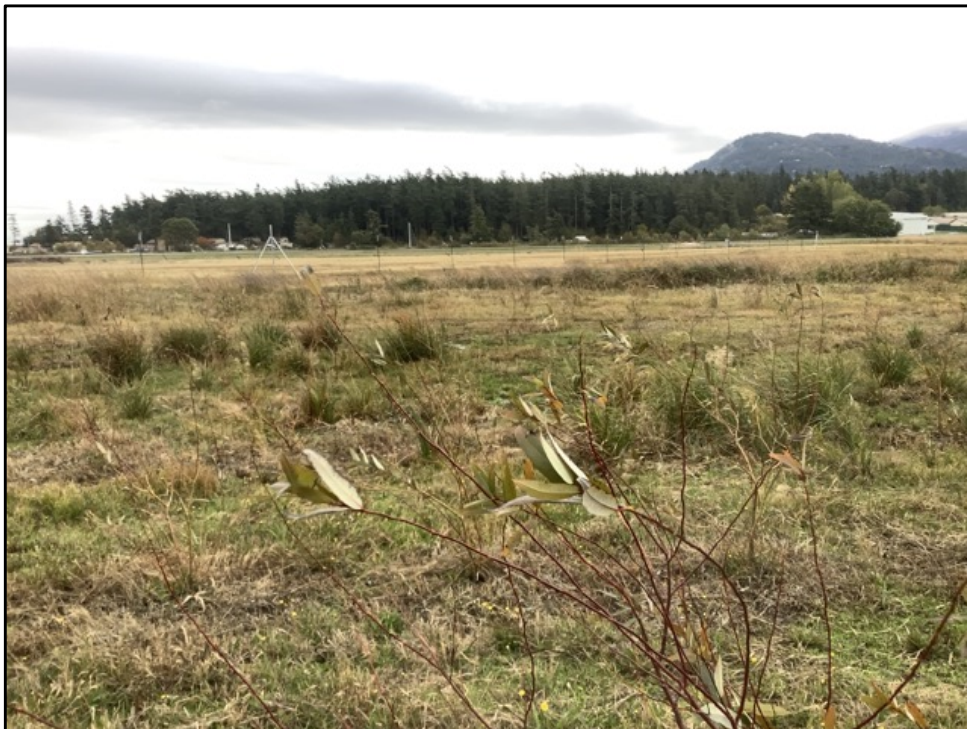
PHOTO 2: PLOT 1-1. LOOKING EAST IN WETLAND
ENHANCEMENT AREA 1, ZONE 1A .

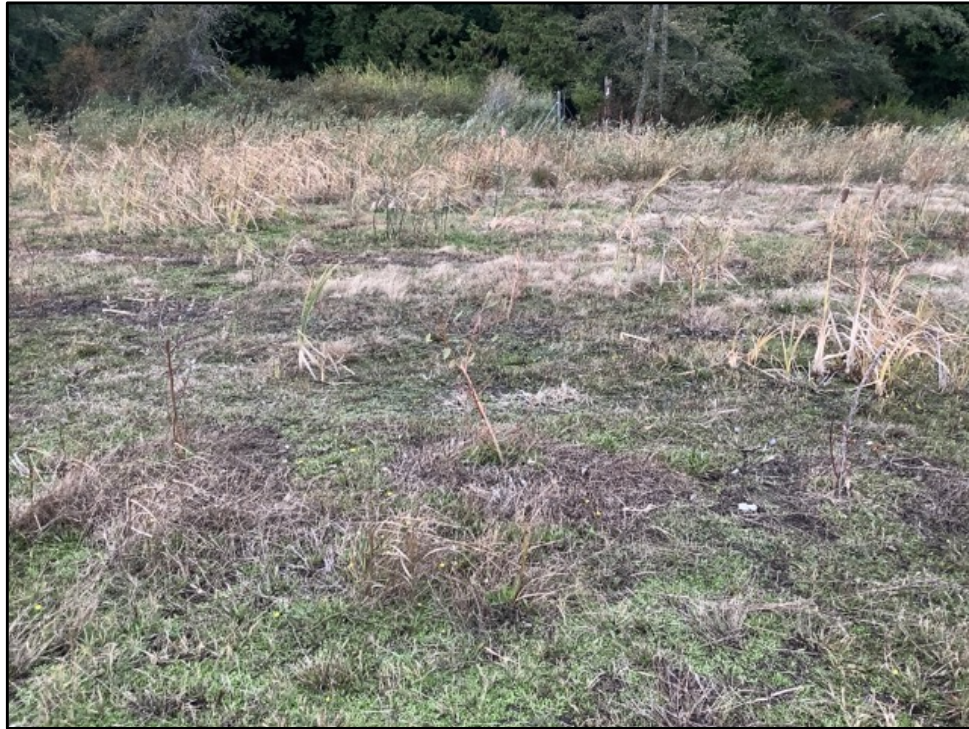
WETLAND ENHANCEMENT AREA 1, ZONE 1A, PLOT 1-2 (35'X55')		
Species	Year 1 Quantity in Sampling Plot	Year 2 Quantity in Sampling Plot
<i>Salix spp.</i>	69	62
Total:	69	62
Percent Survival:		90%

PHOTO 3: PLOT 1-2. FROM EAST LOOKING WEST IN WETLAND ENHANCEMENT AREA 1, ZONE 1A.

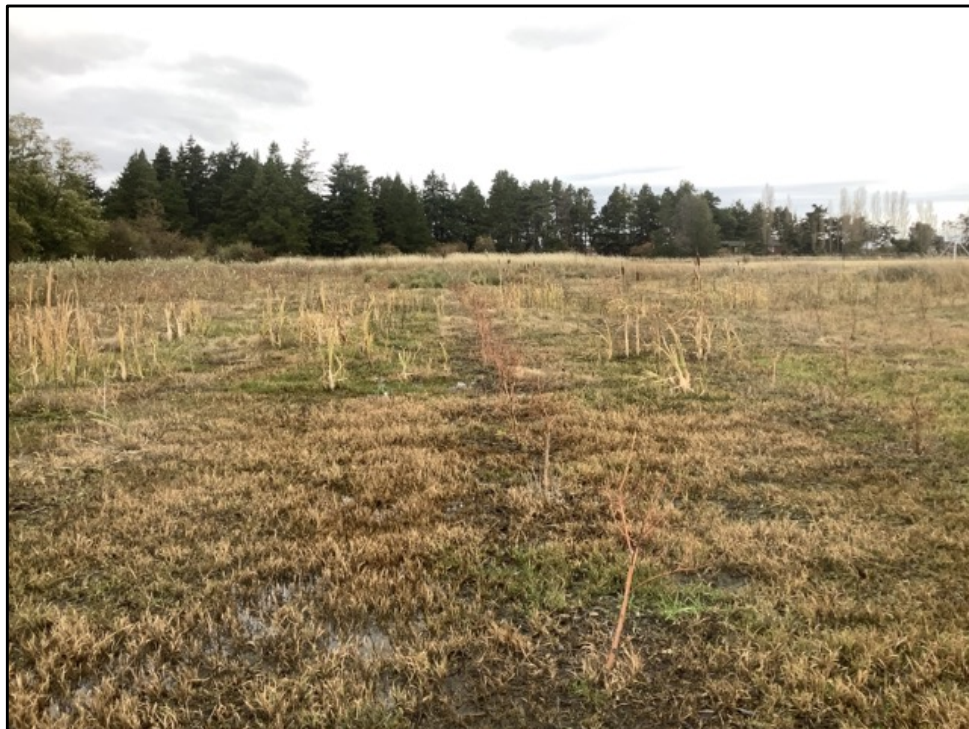
PHOTO 4: PLOT 1-2. FROM SOUTH LOOKING NORTH IN WETLAND ENHANCEMENT AREA 1, ZONE 1A.

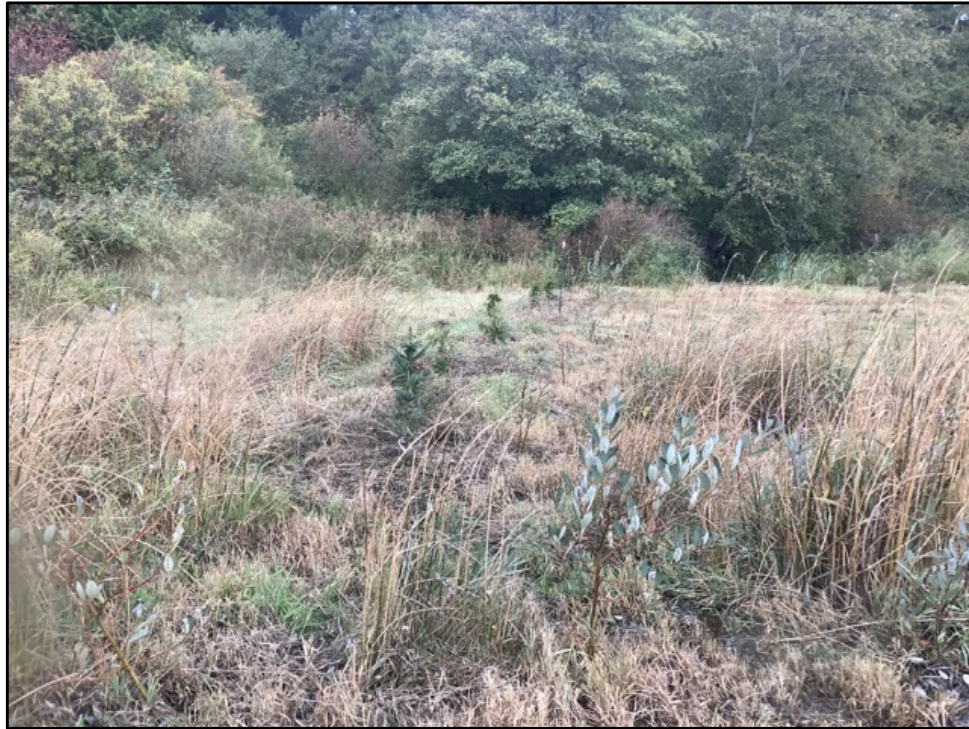
WETLAND ENHANCEMENT AREA 2, ZONE 2B, PLOT 2-1 (40'x50')		
Species	Year 1 Quantity in Sampling Plot	Year 2 Quantity in Sampling Plot
<i>Thuja plicata</i>	5	4
<i>Fraxinus latifolia</i>	4	4
<i>Picea sitchensis</i>	2	2
<i>Salix spp.</i>	16	14
<i>Rubus spectabilis</i>	0	1
<i>Spiraea douglasii</i>	0	1
Total:	27	26
Percent Survival:		96%

**PHOTO 5: PLOT 2-1 FROM EAST LOOKING WEST IN
WETLAND ENHANCEMENT AREA 2, ZONE 2B.**

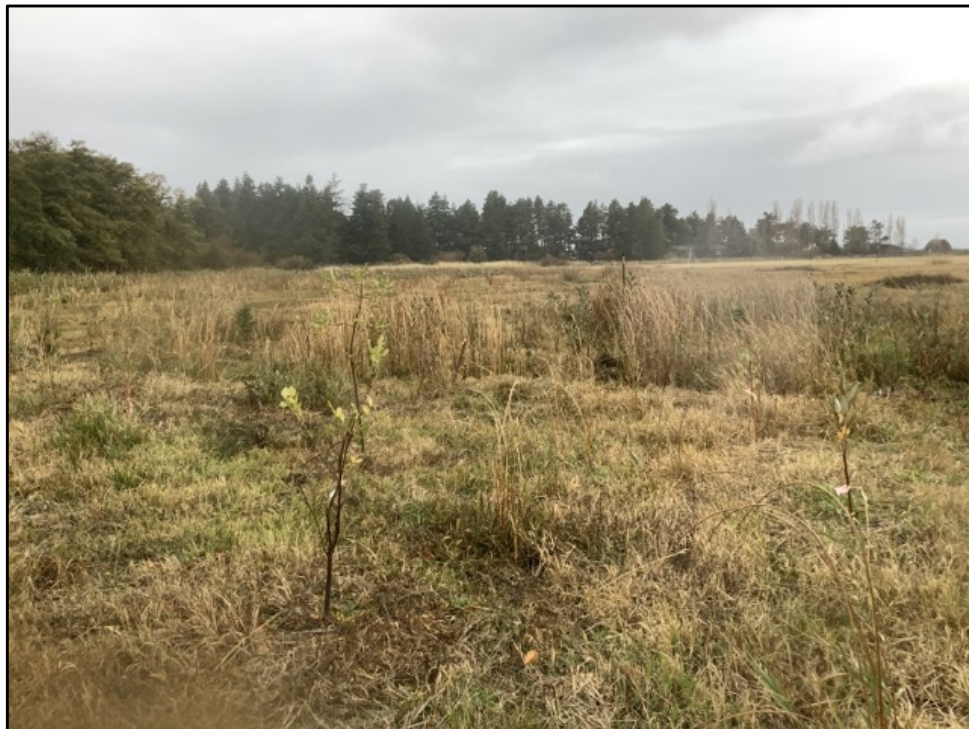
**PHOTO 6: PLOT 2-1. FROM SOUTH LOOKING NORTH IN
WETLAND ENHANCEMENT AREA 2, ZONE 2B.**

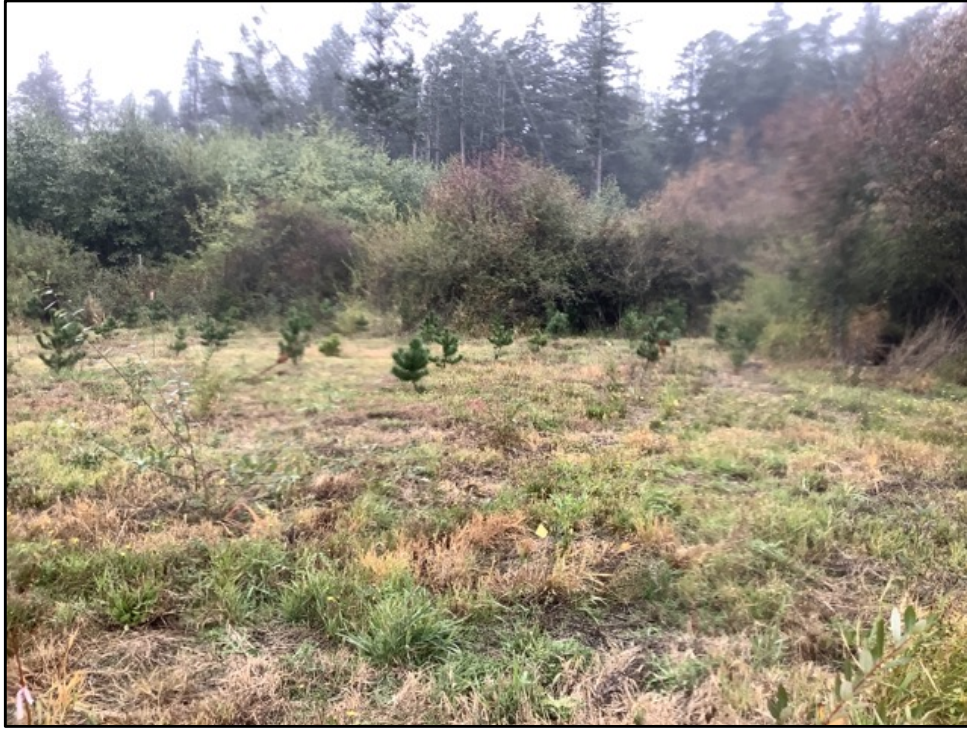
WETLAND ENHANCEMENT AREA 2, ZONE 2B, PLOT 2-2 (40'x50')		
Species	Year 1 Quantity in Sampling Plot	Year 2 Quantity in Sampling Plot
<i>Fraxinus latifolia</i>	1	3
<i>Physocarpus capitatus</i>	5	5
<i>Salix lasiandra</i>	15	15
<i>Pinus contorta</i>	6	5
Total:	27	28
Percent Survival:		>100%

PHOTO 7: PLOT 2-2. FROM EAST LOOKING WEST IN WETLAND ENHANCEMENT AREA 2, ZONE 2B.

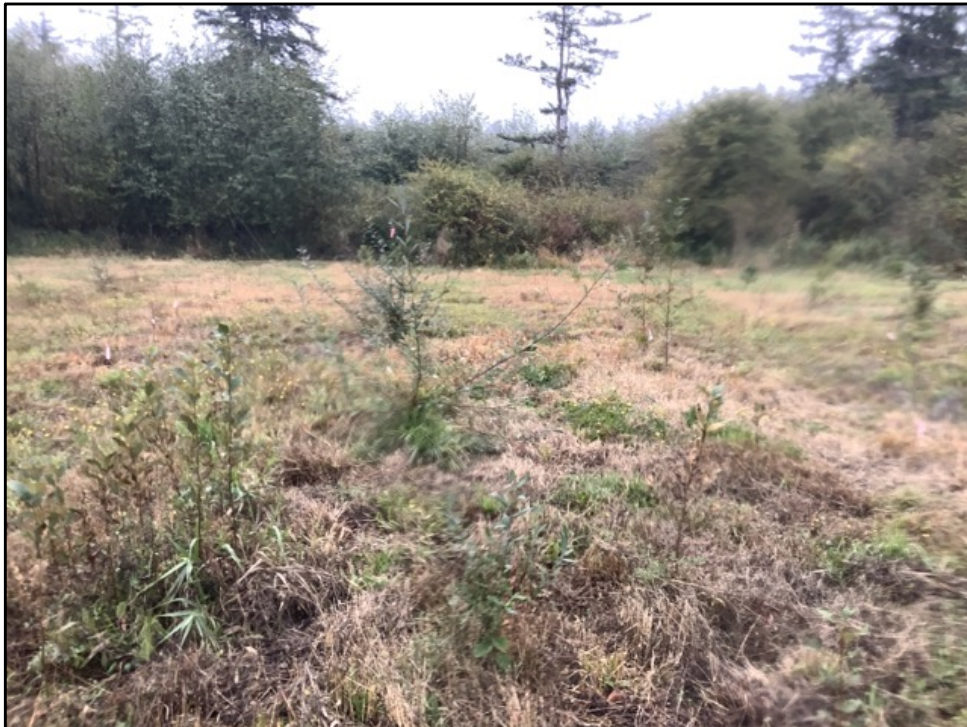
PHOTO 8: PLOT 2-2. FROM NORTH LOOKING SOUTH IN WETLAND ENHANCEMENT AREA 2, ZONE 2B.

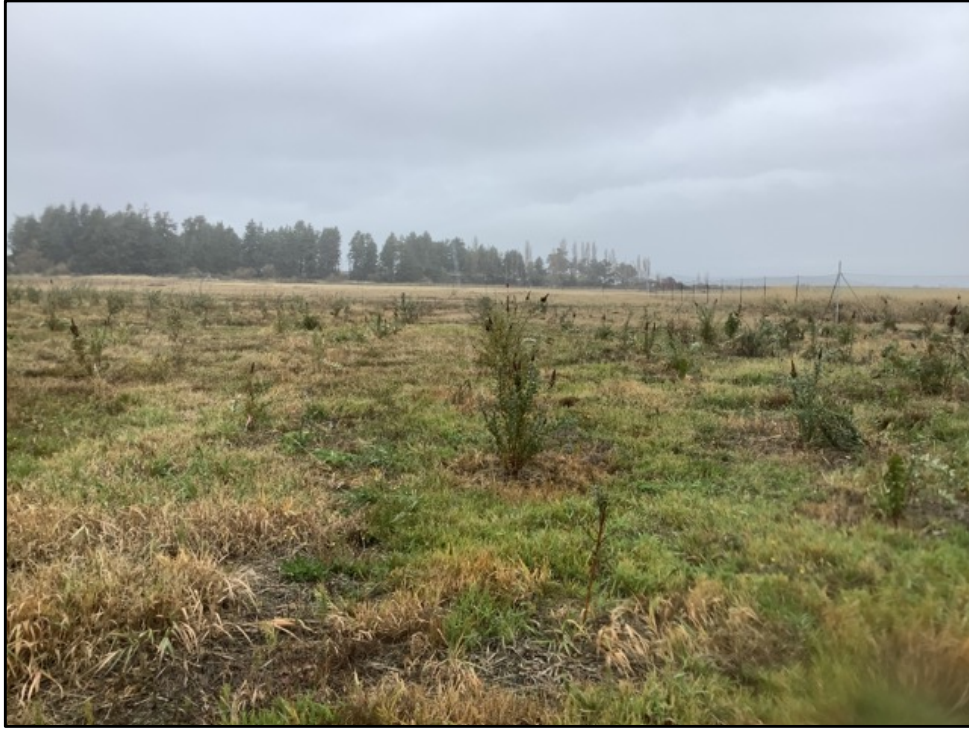
WETLAND ENHANCEMENT AREA 2, ZONE 2C, PLOT 2-3 (40'x50')		
Species	Year 1 Quantity in Sampling Plot	Year 2 Quantity in Sampling Plot
<i>Spiraea douglasii</i>	22	22
<i>Salix hookeriana</i>	3	2
Total:	25	24
Percent Survival:		96%

PHOTO 9: PLOT 2-3. FROM SOUTH LOOKING NORTH IN WETLAND ENHANCEMENT AREA 2, ZONE 2C.

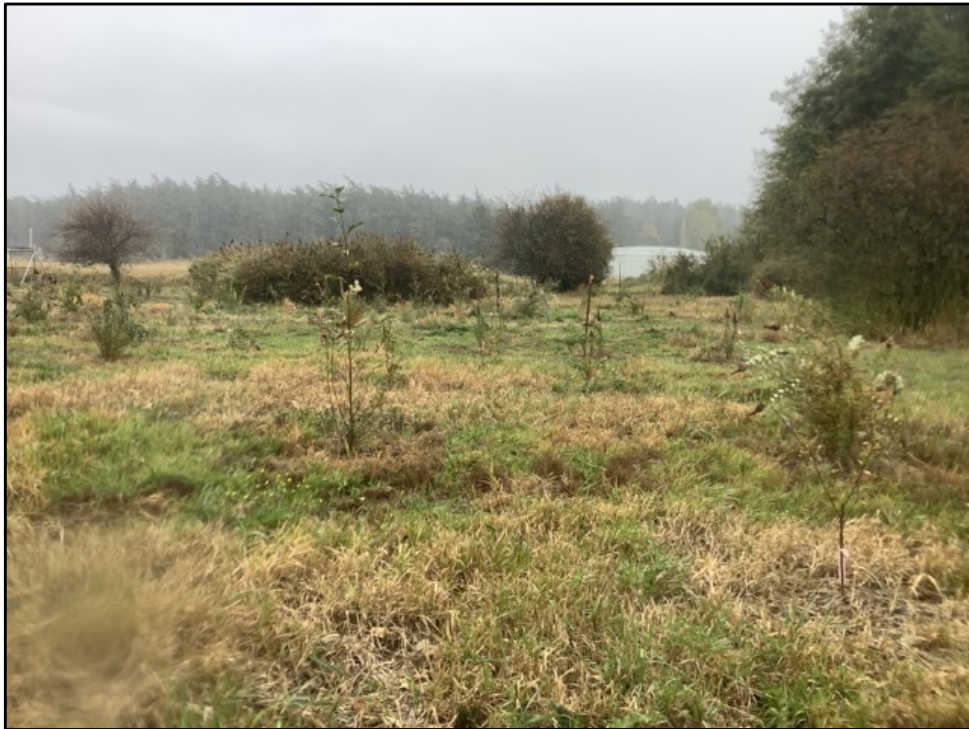
PHOTO 10: PLOT 2-3. FROM WEST LOOKING EAST IN WETLAND ENHANCEMENT AREA 2, ZONE 2C.

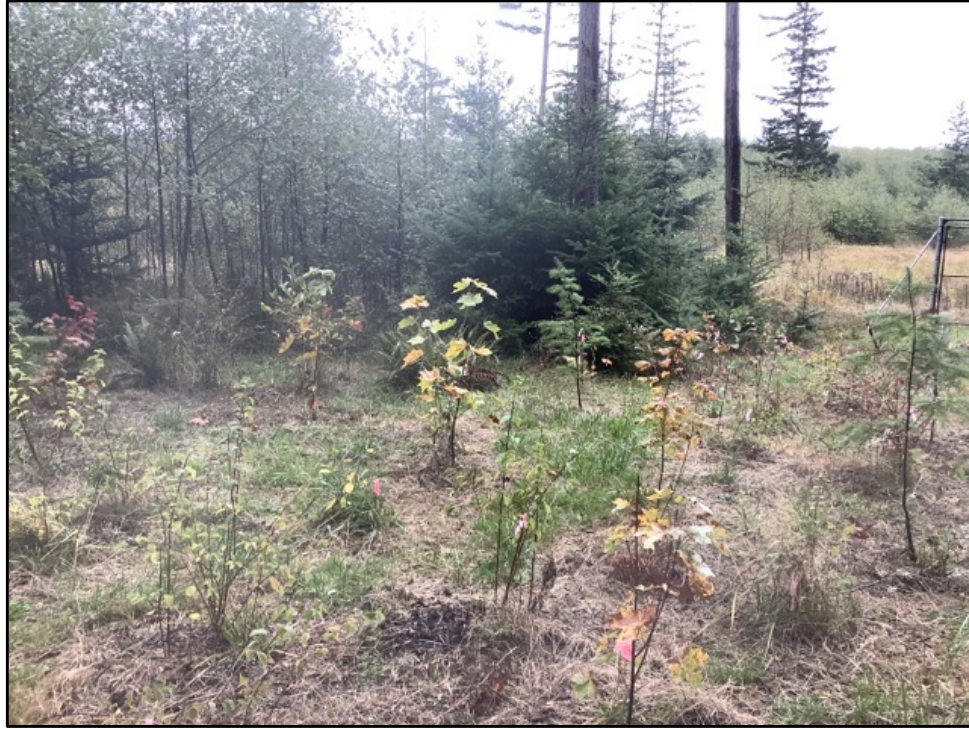
During the October 2021 site inspection, WRI reviewed all the mitigation planting areas, collected data at each sampling plot, and took photos from the established photo points. Survival rates within the sampling plots range from 72 percent to 100 percent, with the lowest survival rates in Buffer Enhancement Area 3. The average survival rate of the sampling plots is 93.5 percent, which is representative of the overall survival across the mitigation areas. While Area 3 is not meeting the 90 percent survival performance standard, this area is densely vegetated and has reached 35 percent aerial cover of native plants, which is the required standard for Year 3 (2022).

BUFFER ENHANCEMENT AREA 3, PLOT 3-1 (30'x30')		
Species	Year 1 Quantity in Sampling Plot	Year 2 Quantity in Sampling Plot
<i>Corylus cornuta</i>	4	2
<i>Acer macrophyllum</i>	12	11
<i>Pseudotsuga menziesii</i>	4	4
<i>Holodiscus discolor</i>	18	8
<i>Philadelphus lewisii</i>	12	11
Total:	50	36
Percent Survival:		72%

**PHOTO 13: PLOT 3-1. FROM EAST LOOKING WEST IN
BUFFER ENHANCEMENT AREA 3.**

- Re-flag installed plants as necessary prior to invasive species removal/mowing.
- Remove invasive species (including Himalayan blackberry) and mow/treat reed canary grass a minimum of two times between April and October 2022.
- Repair deer fencing as necessary.
- Provide irrigation as needed during the dry season (approximately July 15 – October 15).
- Replace plants as necessary in fall 2022 to achieve the required 35 percent aerial coverage.

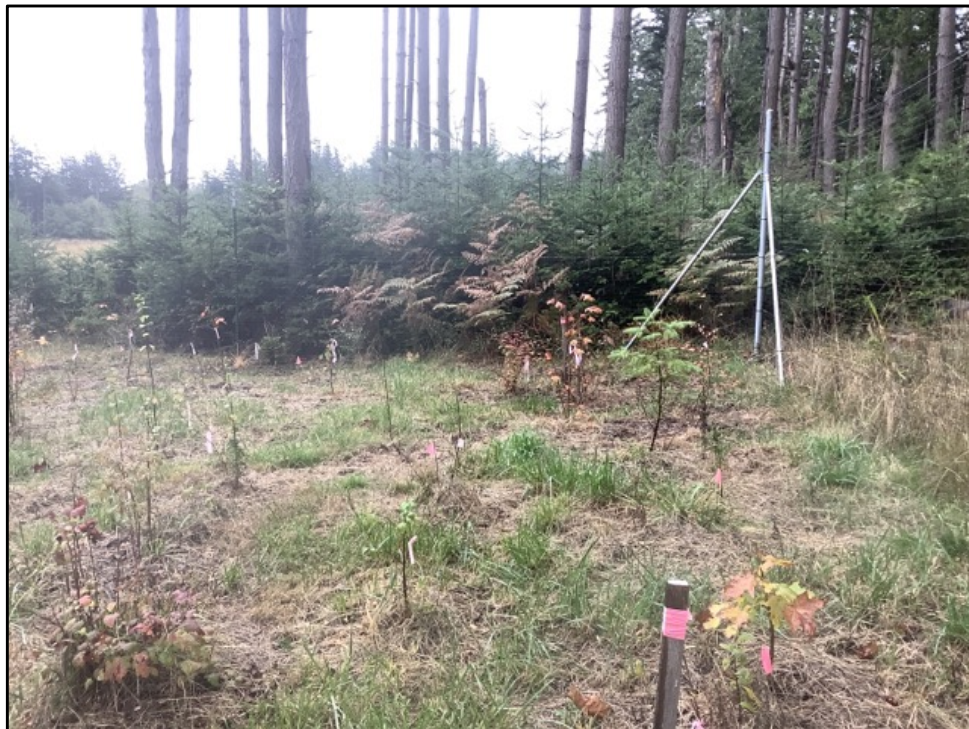
**PHOTO 14: PLOT 3-1. FROM SOUTH LOOKING NORTH IN
BUFFER ENHANCEMENT AREA 3.**

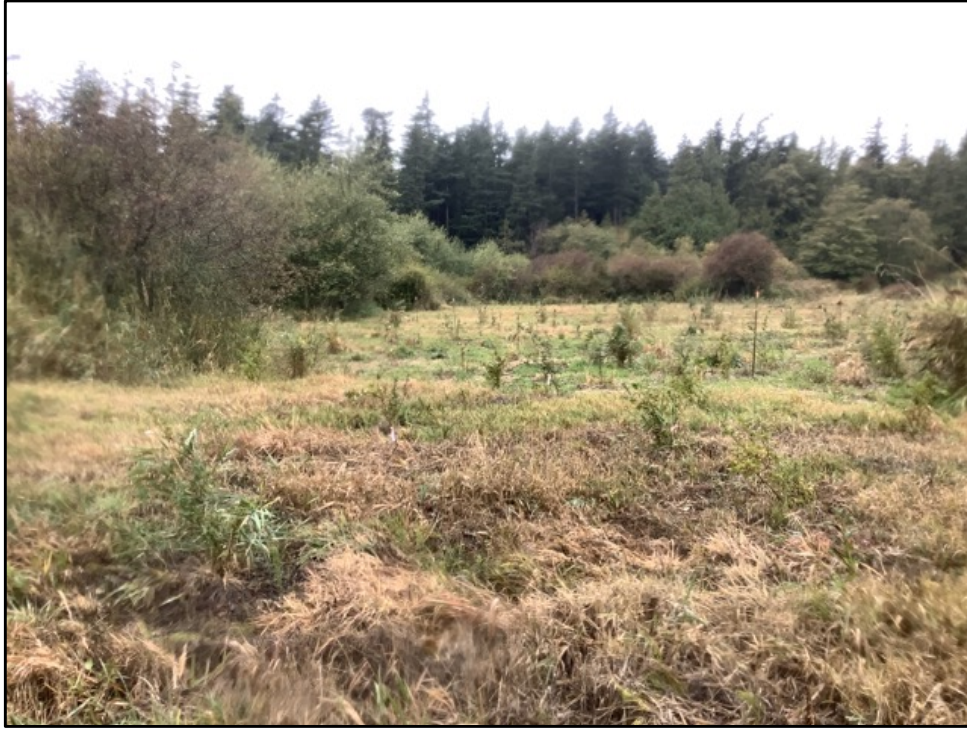
WETLAND ENHANCEMENT AREA 2, ZONE 2D, PLOT 2-4 (40'x50')		
Species	Year 1 Quantity in Sampling Plot	Year 2 Quantity in Sampling Plot
<i>Physocarpus capitatus</i>	19	18
Total:	19	18
Percent Survival:		95%

PHOTO 11: PLOT 2-4. FROM EAST LOOKING WEST IN WETLAND ENHANCEMENT AREA 2, ZONE 2D.

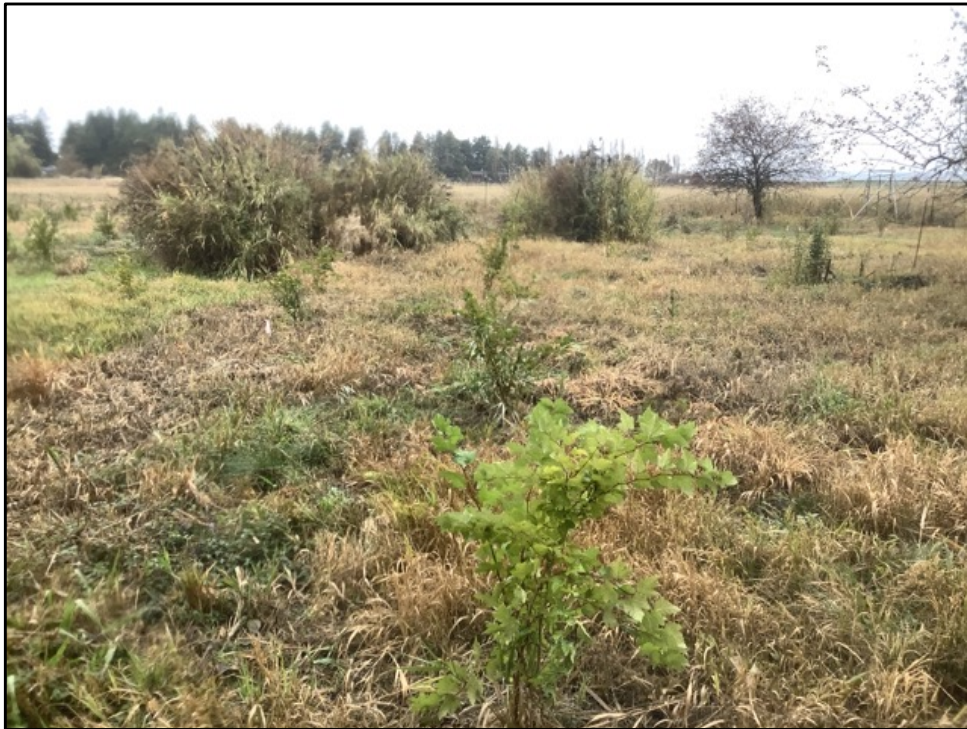
PHOTO 12: PLOT 2-4. FROM SOUTH LOOKING NORTH IN WETLAND ENHANCEMENT AREA 2, ZONE 2D.

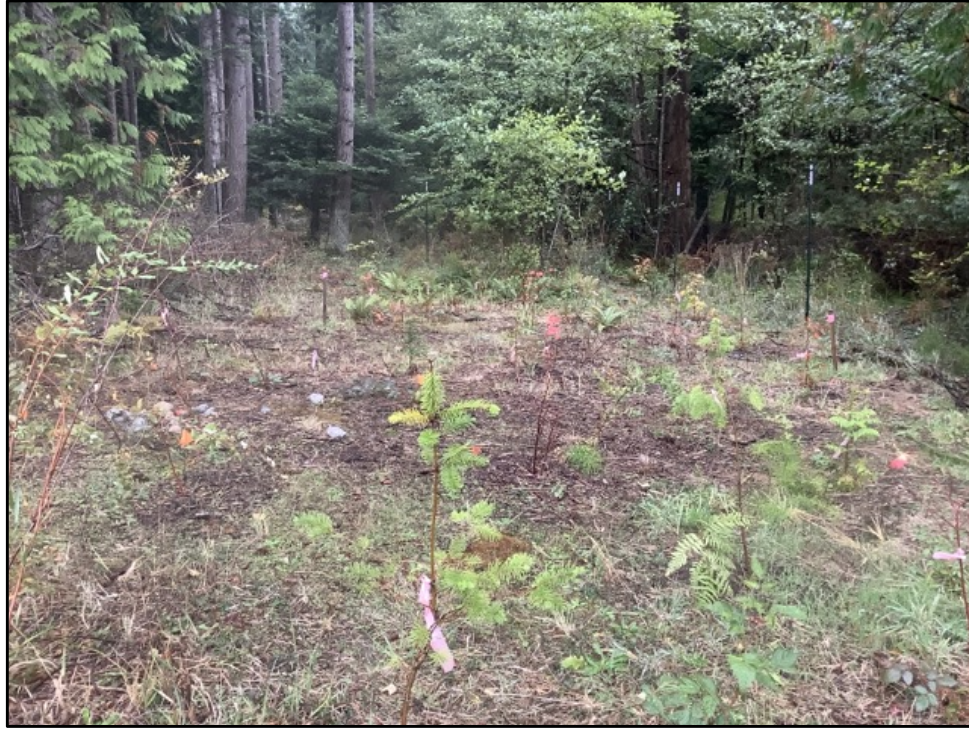
BUFFER ENHANCEMENT AREA 3, PLOT 3-2 (30'x30')		
Species	Year 1 Quantity in Sampling Plot	Year 2 Quantity in Sampling Plot
<i>Corylus cornuta</i>	3	2
<i>Acer macrophyllum</i>	5	5
<i>Pseudotsuga menziesii</i>	4	3
<i>Holodiscus discolor</i>	4	4
<i>Thuja plicata</i>	5	4
Total:	21	18
Percent Survival:		86%

PHOTO 15: PLOT 3-2. FROM SOUTH LOOKING NORTH IN BUFFER ENHANCEMENT AREA 3.

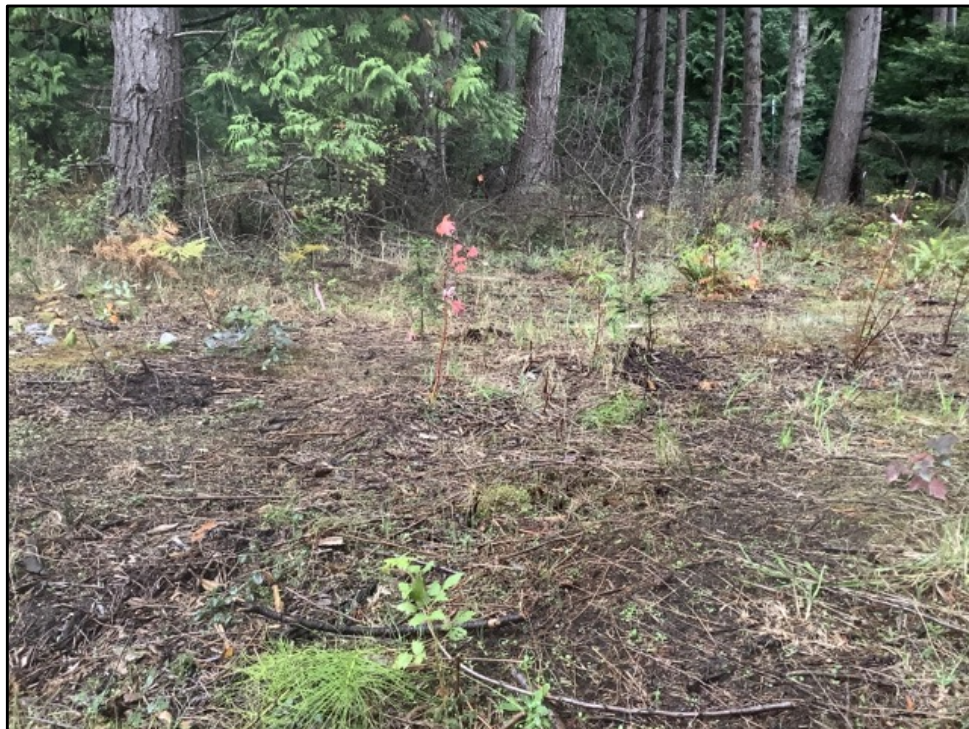
PHOTO 16: PLOT 3-2. FROM EAST LOOKING WEST IN BUFFER ENHANCEMENT AREA 3.

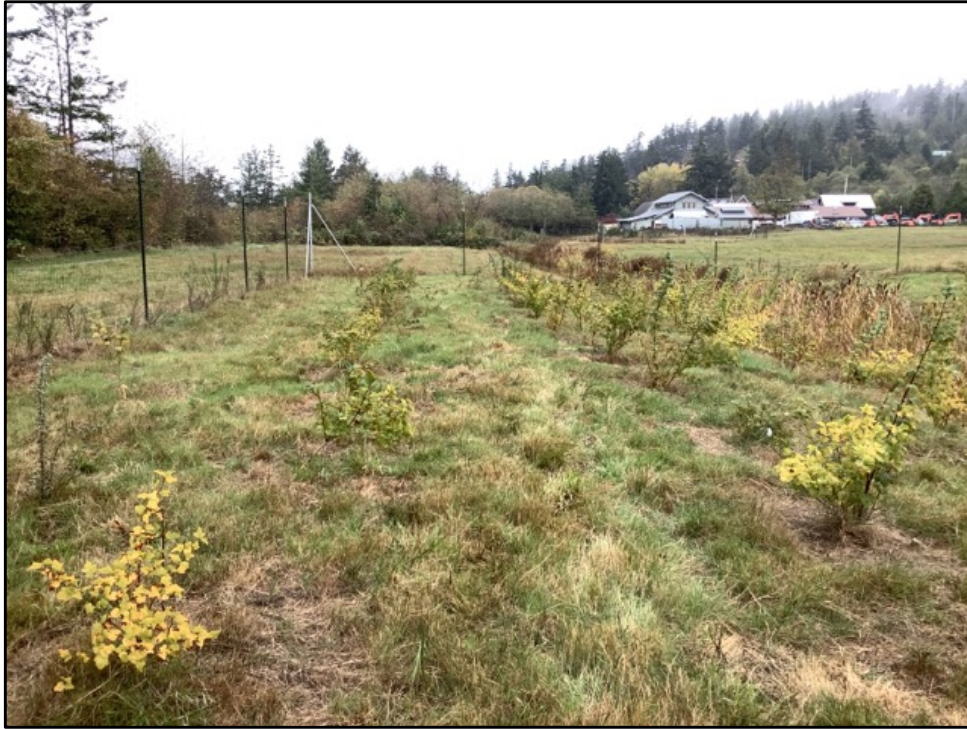
WETLAND RESTORATION AREA 4, PLOT 4-1 (25'x60')		
Species	Year 1 Quantity in Sampling Plot	Year 2 Quantity in Sampling Plot
<i>Spiraea douglasii</i>	3	2
<i>Physocarpus capitatus</i>	28	28
Total:	31	30
Percent Survival:		97%

PHOTO 17: PLOT 4-1. FROM NORTH LOOKING SOUTH.

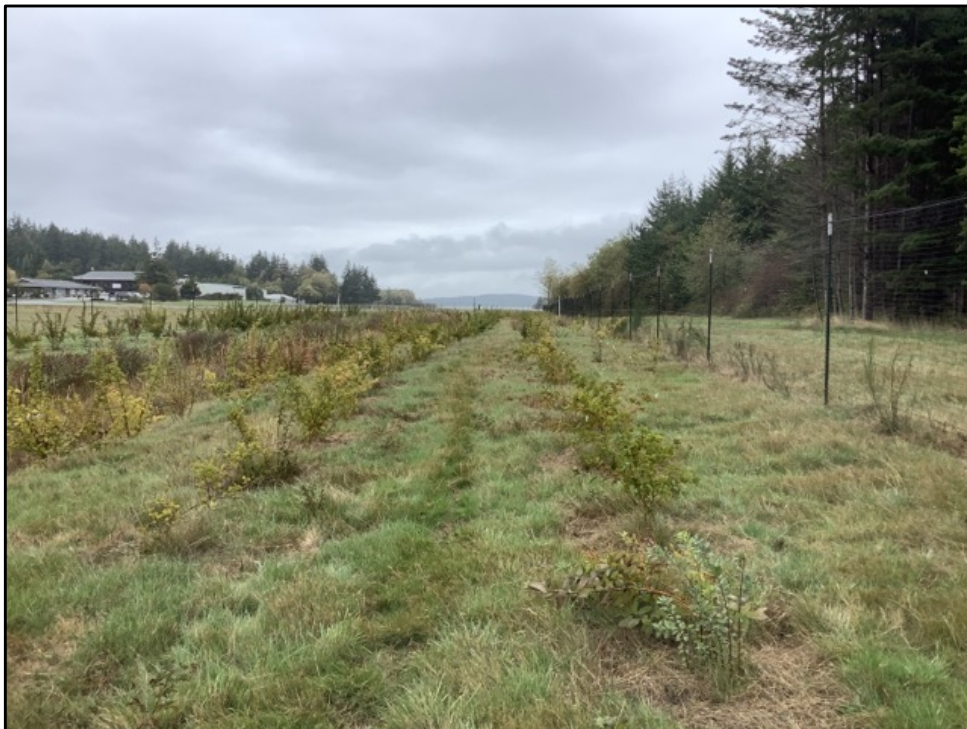
PHOTO 18: PLOT 4-1. FROM SOUTH LOOKING NORTH.

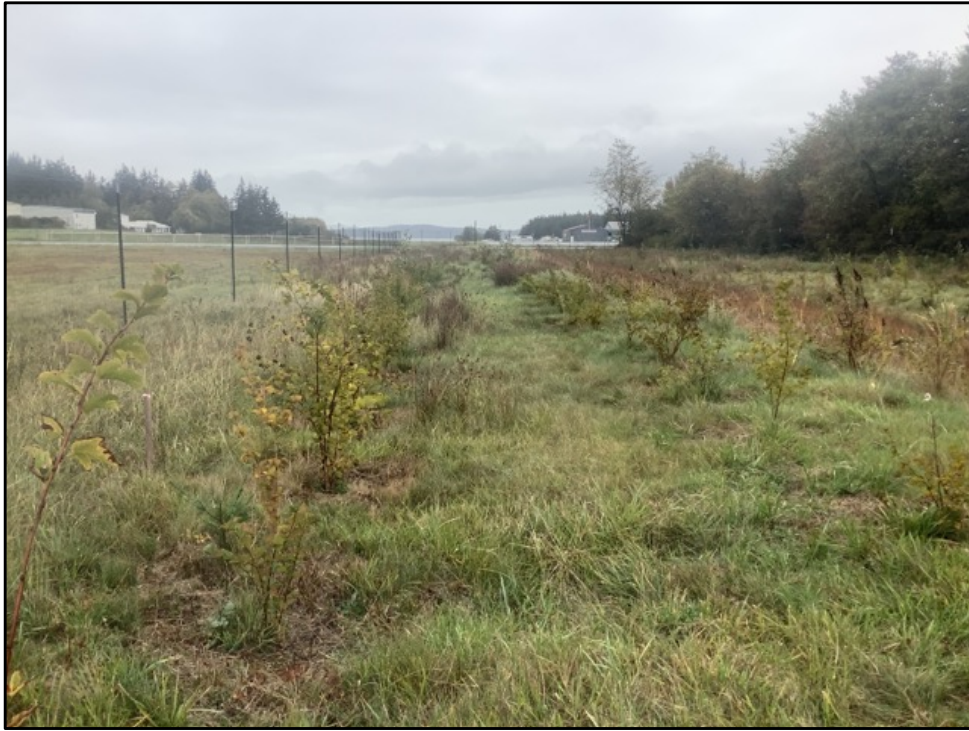
WETLAND RESTORATION AREA 4, PLOT 4-2 (25'x60')		
Species	Year 1 Quantity in Sampling Plot	Year 2 Quantity in Sampling Plot
<i>Spiraea douglasii</i>	13	12
<i>Physocarpus capitatus</i>	23	23
Total:	36	35
Percent Survival:		97%

PHOTO 19: PLOT 4-2. FROM SOUTH LOOKING NORTH.

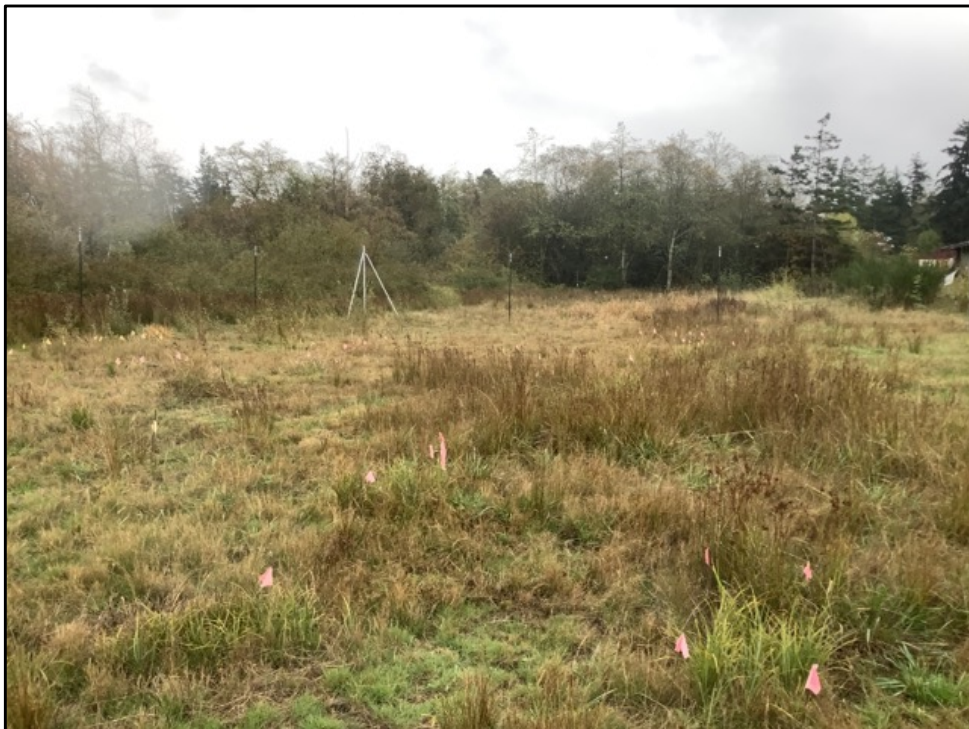
WETLAND RESTORATION AREA 5, PLOT 5-1 (25'x45')		
Species	Year 1 Quantity in Sampling Plot	Year 2 Quantity in Sampling Plot
<i>Carex obnupta</i>	28	30
<i>Physocarpus capitatus</i>	21	0
<i>Juncus effusus</i>	0	21
Total:	49	51
Percent Survival:		>100%

PHOTO 20: PLOT 5-1. LOOKING SOUTHEAST THROUGH EMERGENT PLANTS IN AREA 5.
